Lake Iroquois Association

Tributary Water Quality Monitoring 2019

Shannon Kelly
Lake Iroquois Association
Hinesburg/Williston/Richmond, VT

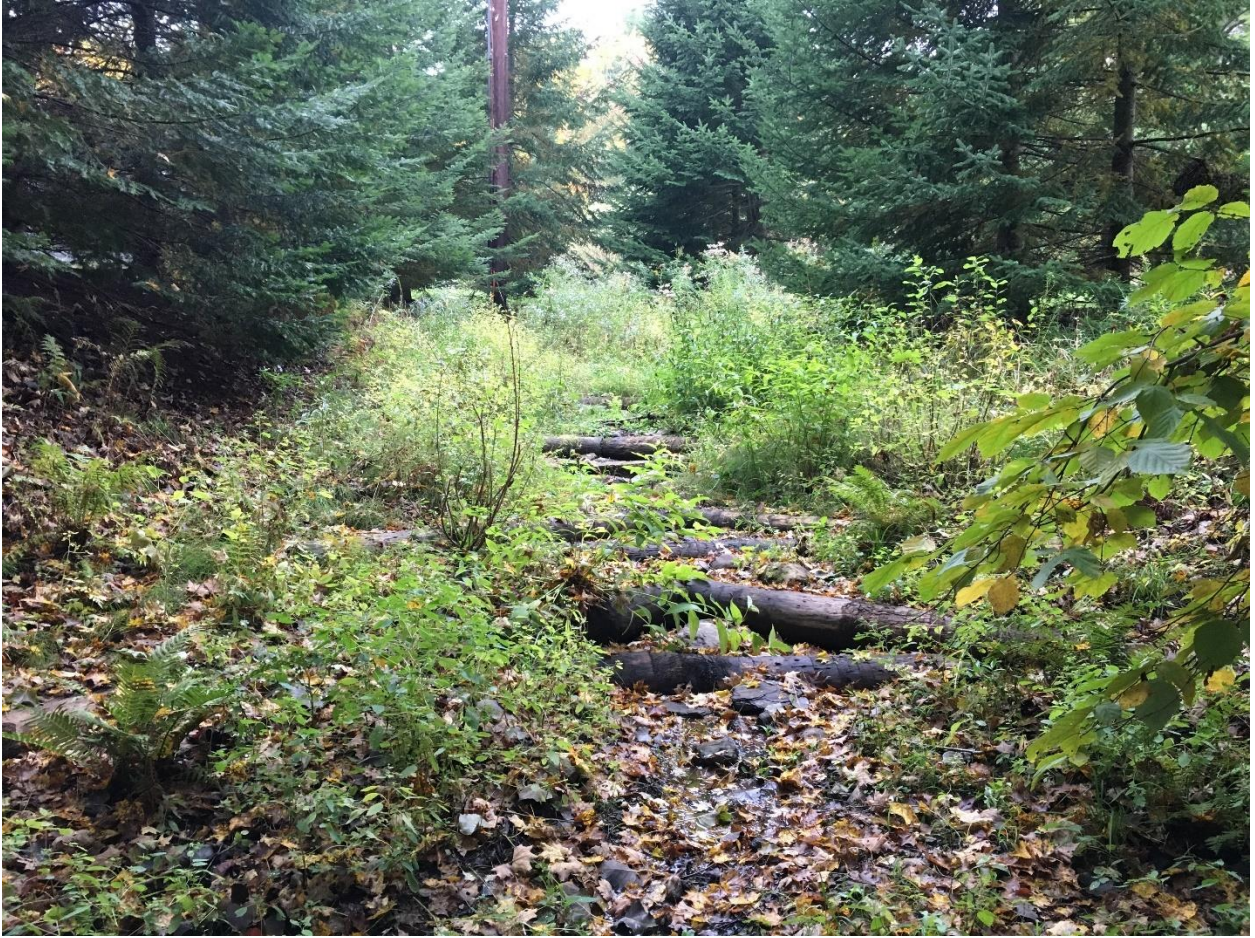
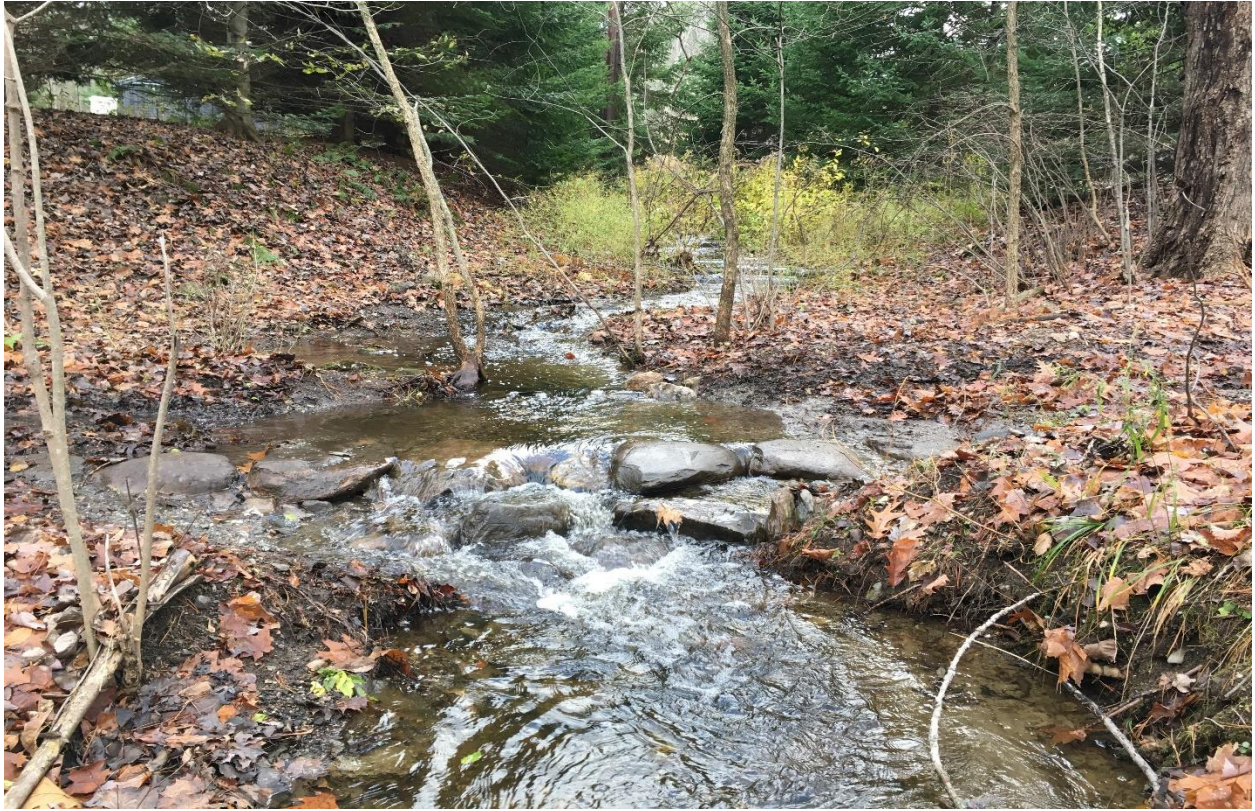
LaRosa Volunteer Water Quality Monitoring Analytical Services Partnerships Montpelier, VT
Ecosystem Restoration Program - Culvert & Stream Restoration Project - Pine Shore Rd, Hinesburg, VT

Photograph taken mid-morning On November 1st, 2019 following a major storm

The restoration work is performing as designed with no major washouts or developing erosion features - and the stream is rediscovering its channel!
