Lake Iroquois Stream Remediation and Erosion Control Project

Part 1: Stream Remediation & Flood Plain Restoration

Report by P. Suozzi

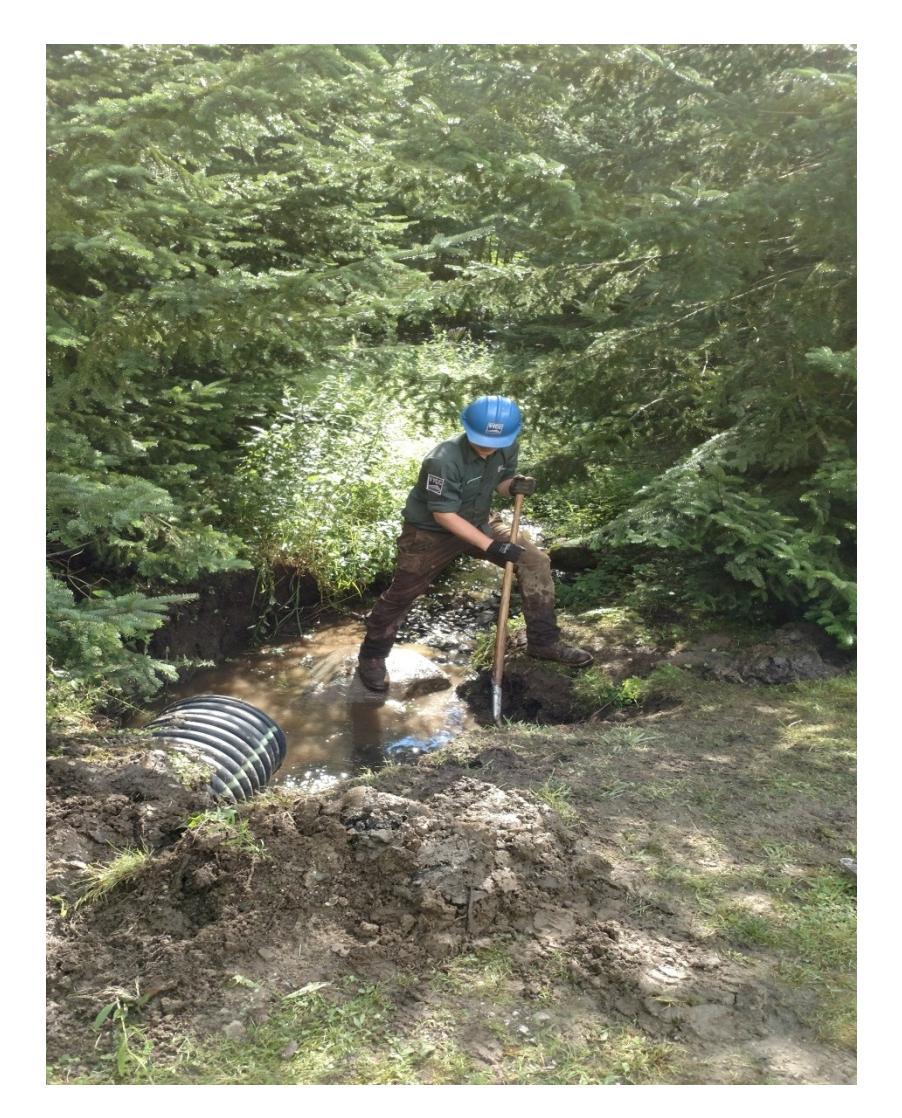
Placing Rock at outlet of rain garden

This culvert, which goes under a driveway could not be removed, so rock was placed at the outlet to reduce the drop which was causing considerable erosion. Rock was also added on either side to prevent further stream bank erosion.

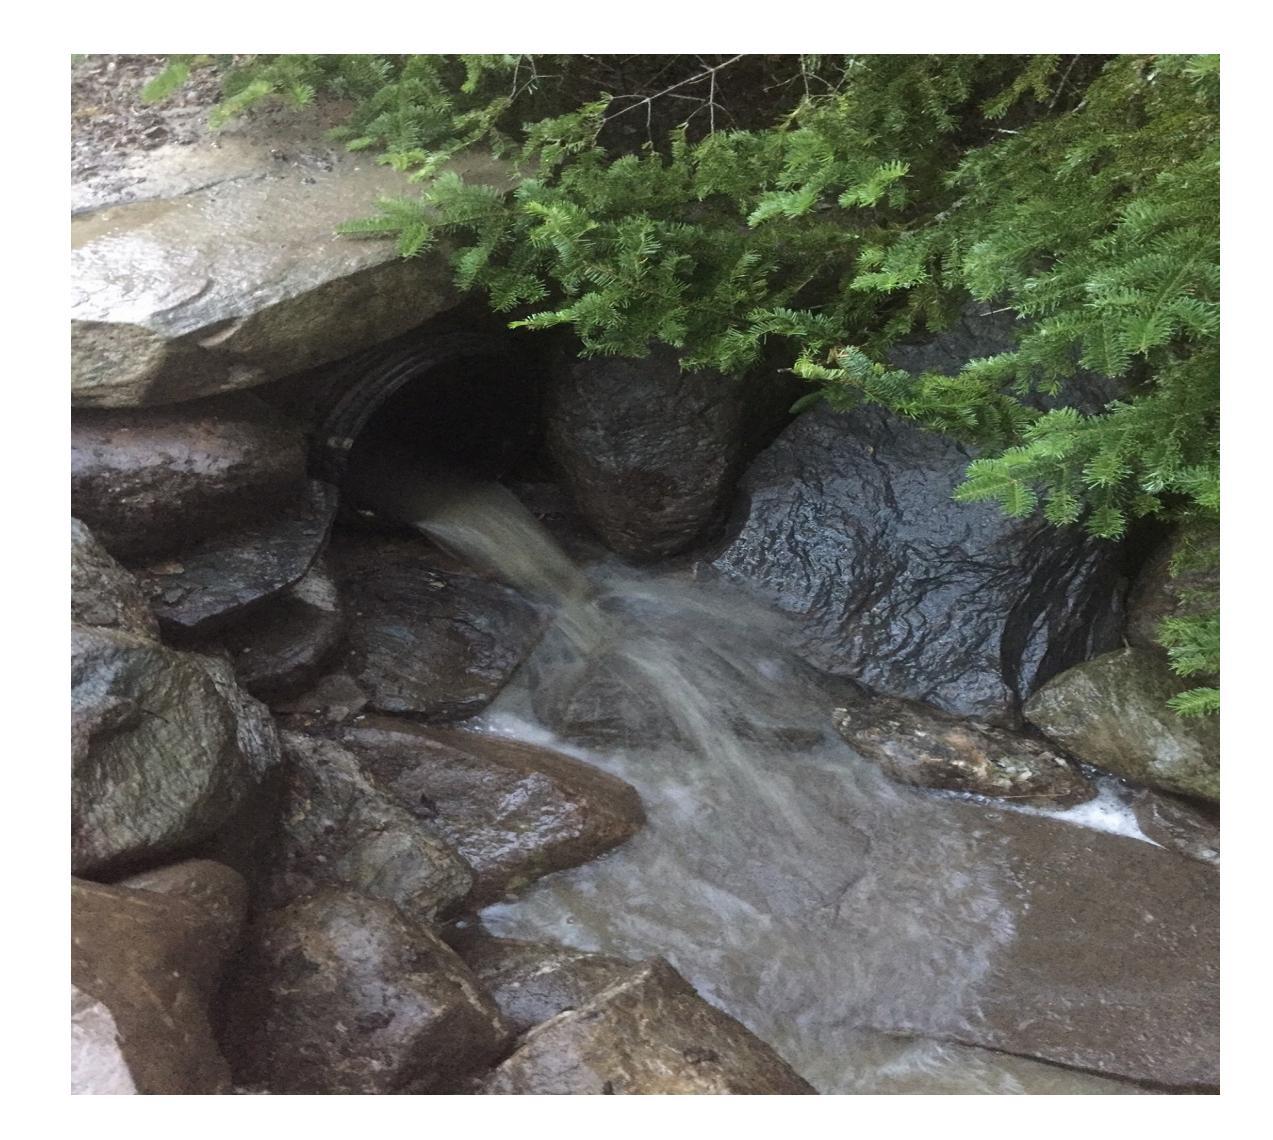
Completed rock armoring at culvert outlet

The water now flows more parallel to streambed. The rock also slows the velocity and traps sediment. Rocks on either side also protect banks from further erosion.

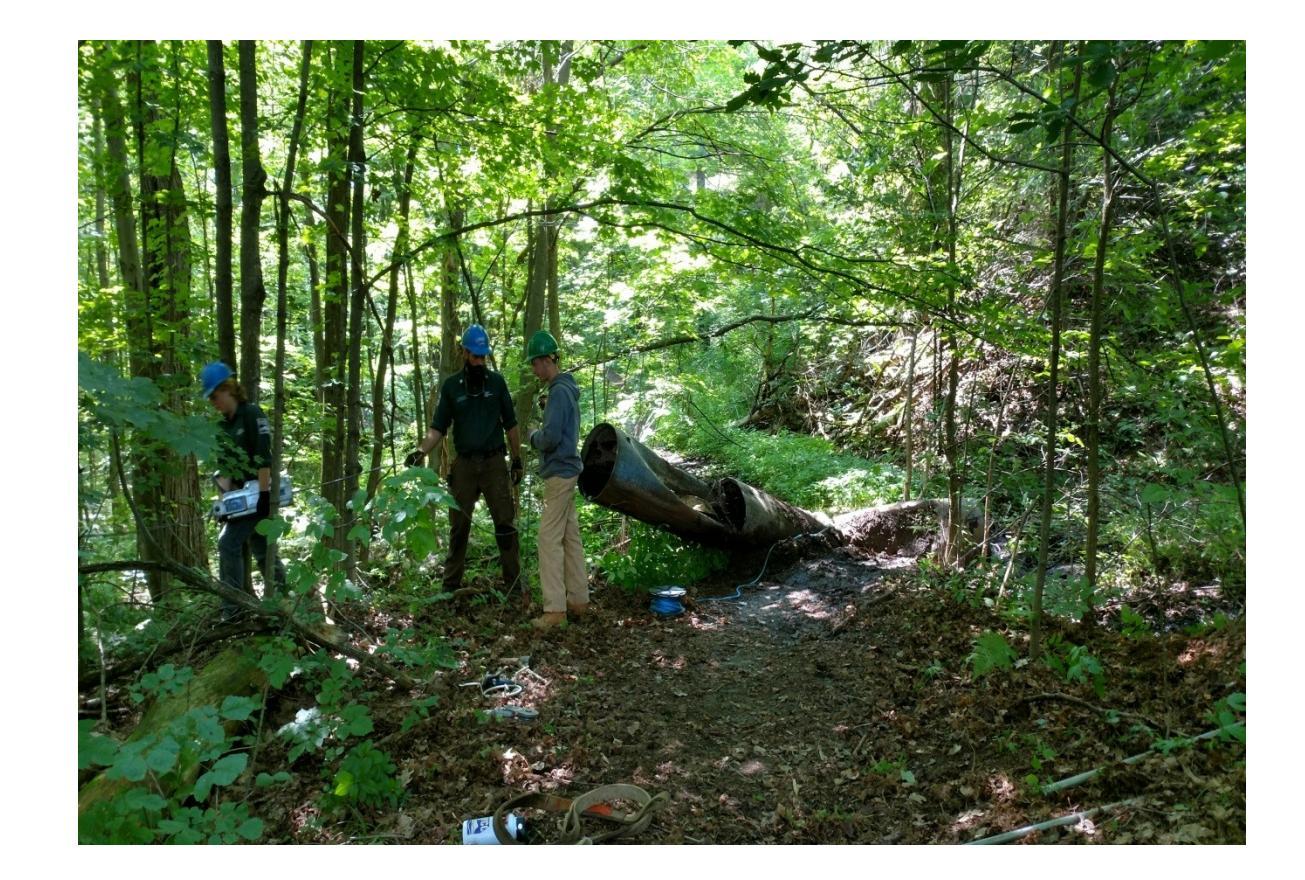
Removal of old culvert

The VYCC crew removed the old culvert using a winch and ropes.

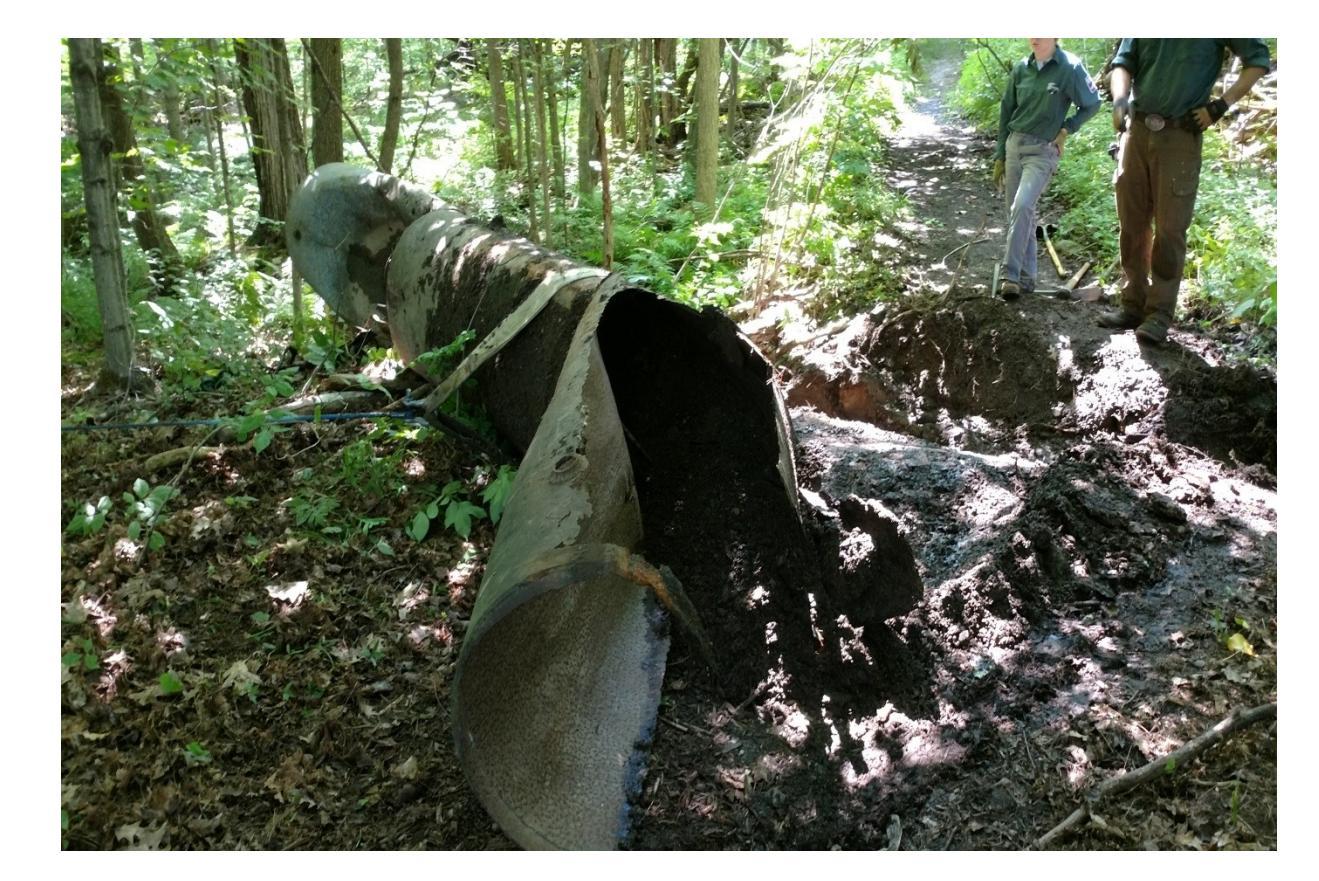
Culvert is out

The old culvert was placed in the right of way over 60 years ago. The culvert was actually several water heaters welded together.

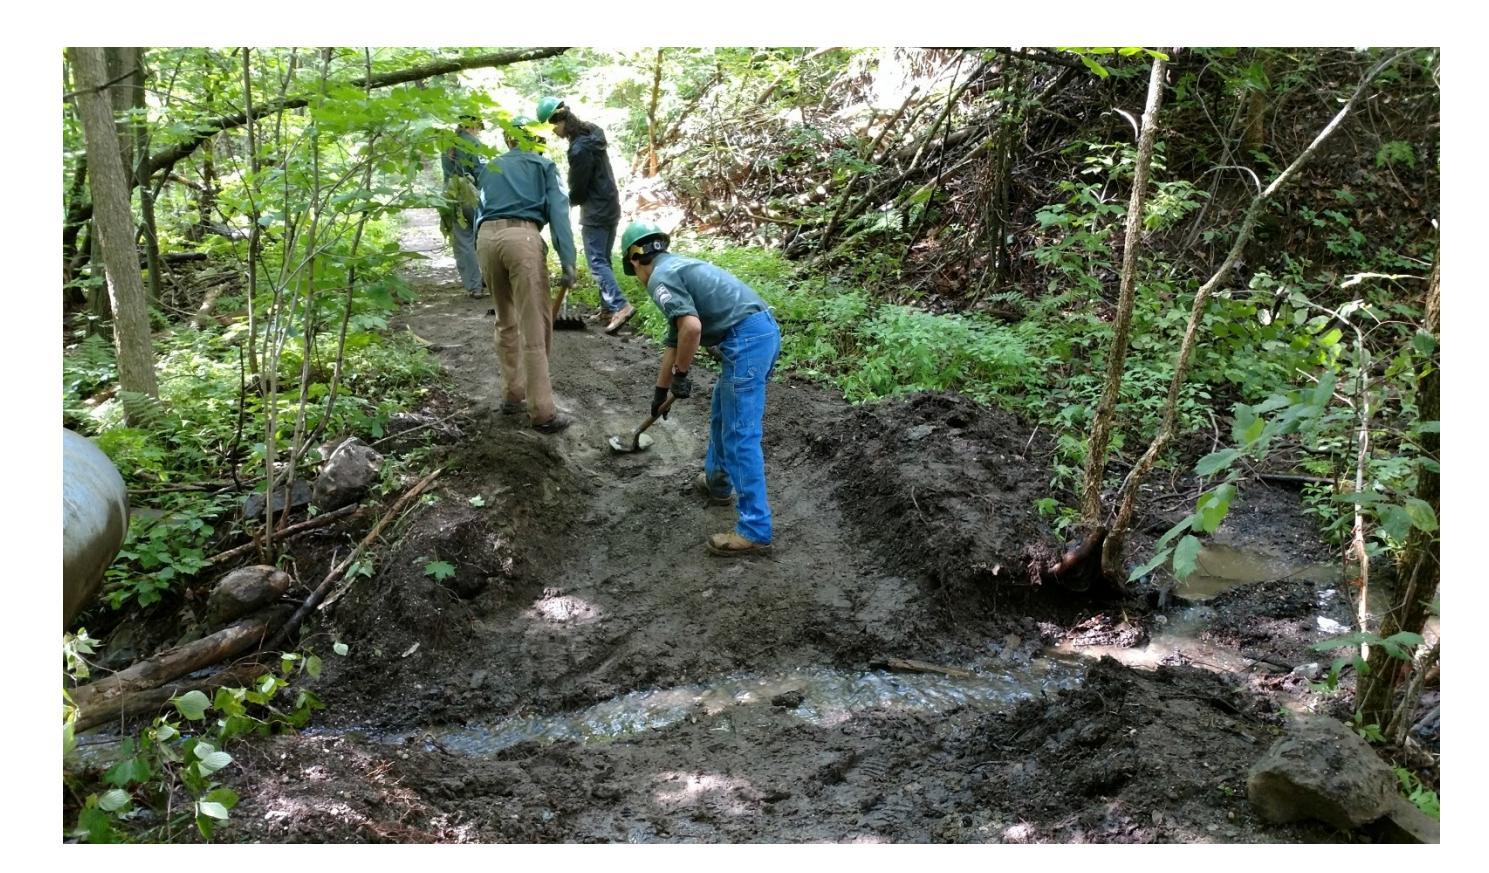
Regrading path after culvert removal

In order to allow the stream to resume a more natural flow, the VYCC crew regraded the path where the old culvert had been.

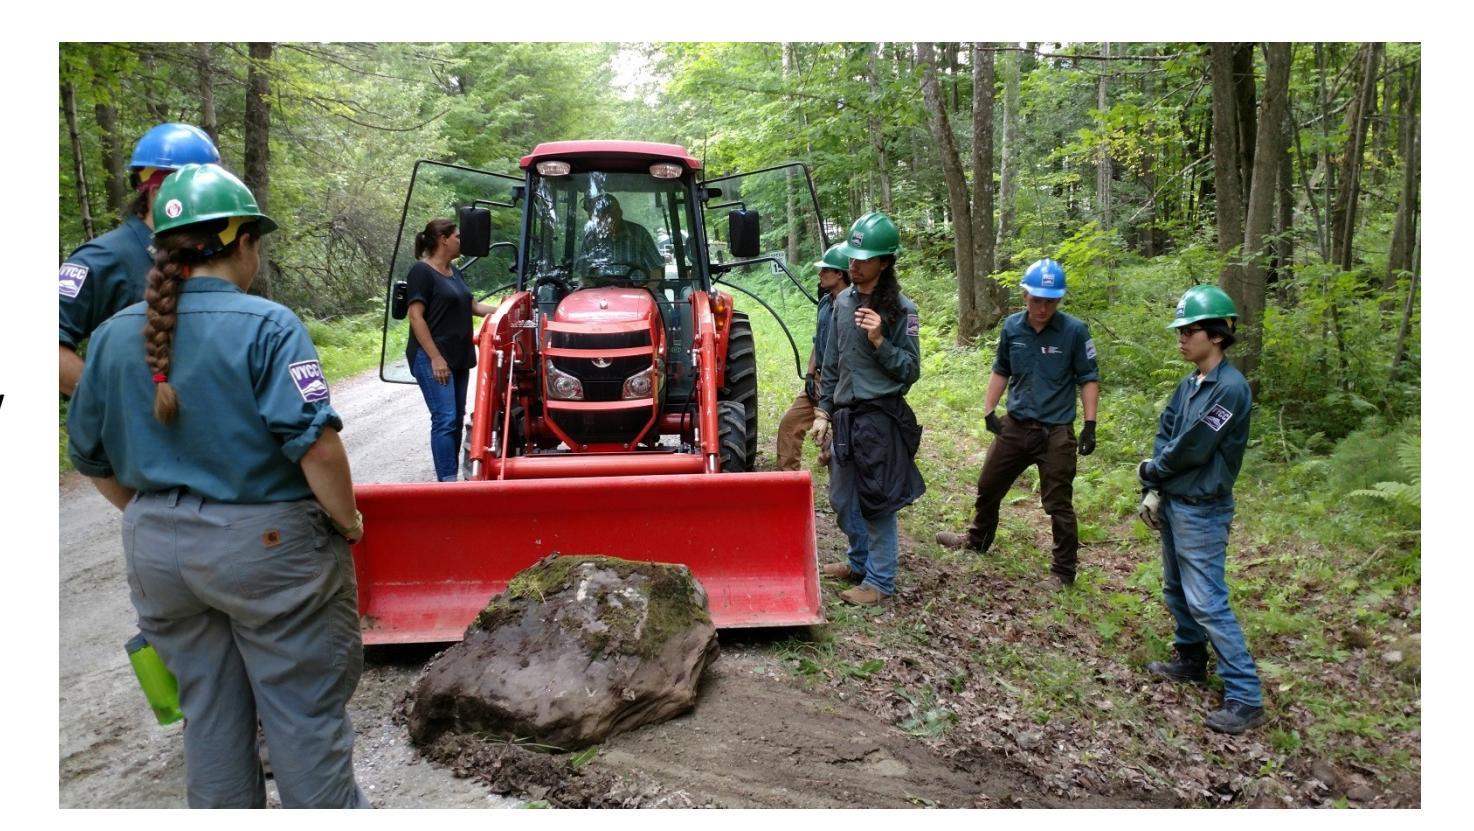
Gathering rock for the path

Rock was needed to form several weirs downstream of the path and to create a stream crossing on the path. Neighbor Doug Lantman volunteered to work with the crew using his tractor to retrieve rocks on the property and move them to the path. This saved much time for the crew and money for the project as rock did not need to be purchased.

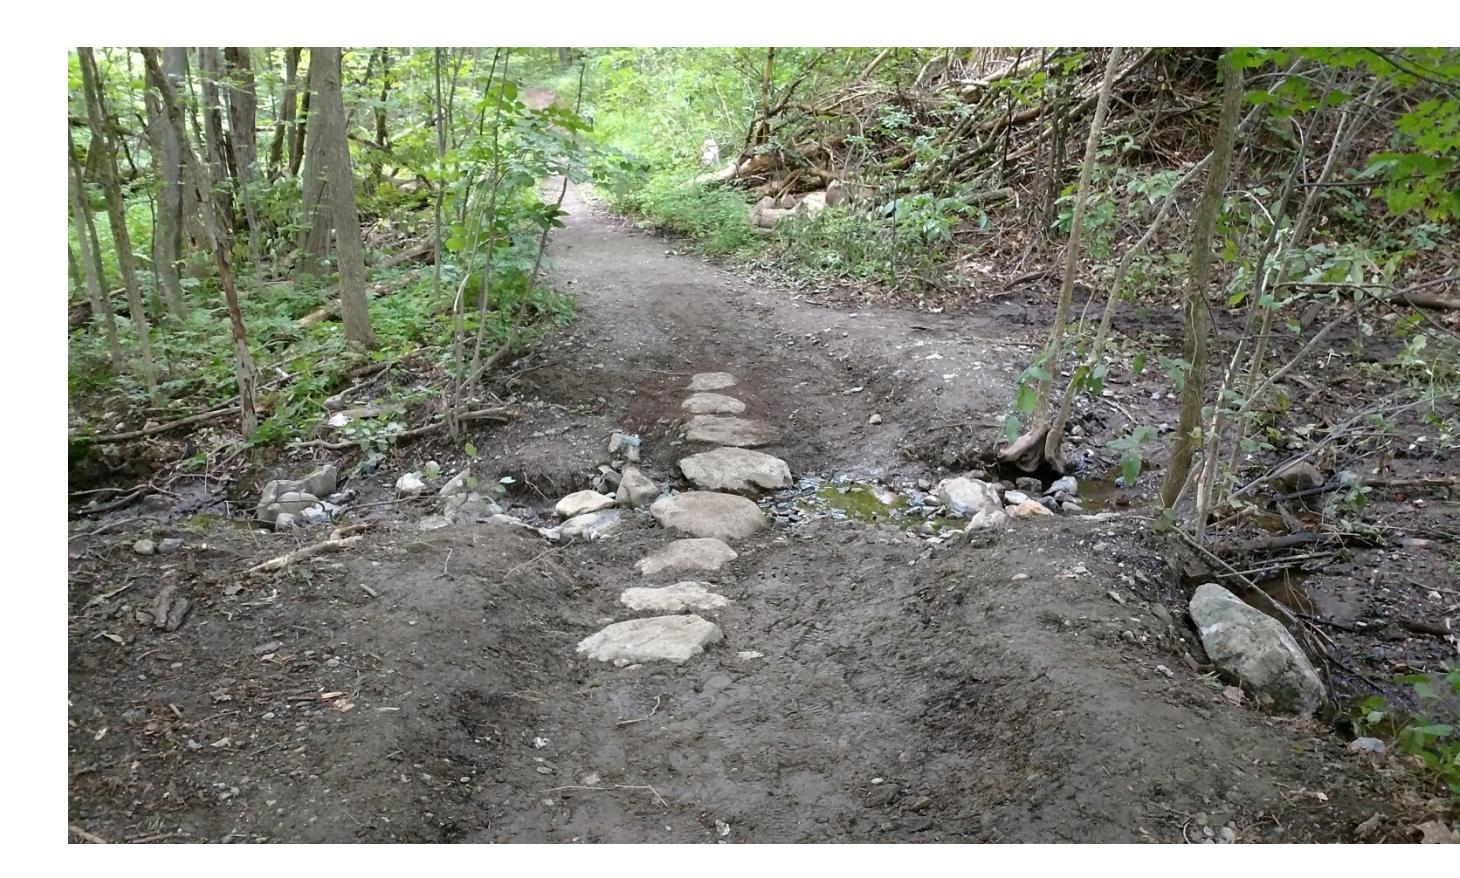
Completed work on the path

After regrading the crew placed several rock weirs downstream (to the left of the crossing in the picture) to slow water velocity and added stepping stones where the old culvert had been. The stream can flow naturally and people can walk across dry shod, even in heavy rain.

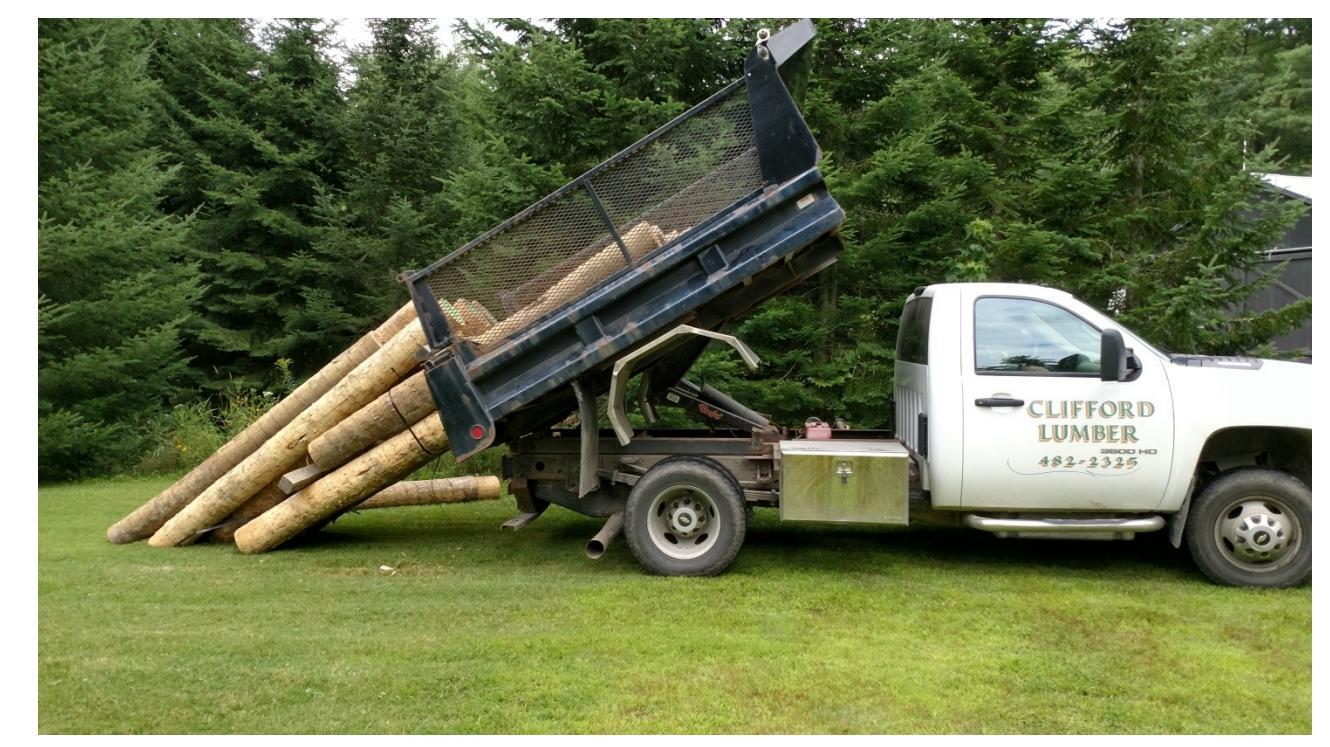
Timber Delivery

In order to allow the stream to spread into its natural flood plain, to reduce water velocity, and capture sediment before it enters the lake, timber check dams were created upstream of the walking path.

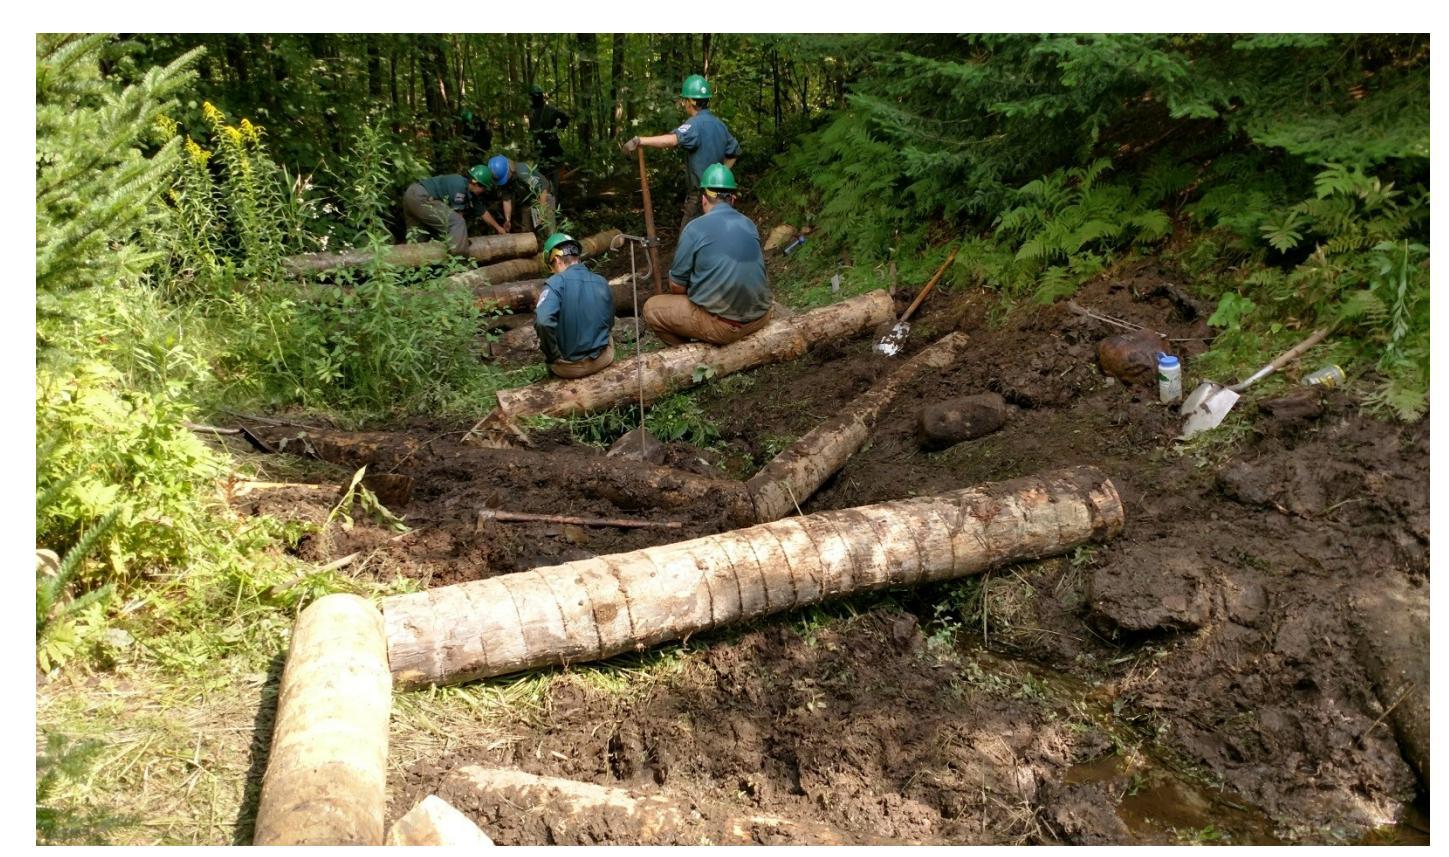
Placing the check dams

The VYCC crew are being shown how to place the timber check dams in the stream bed. Although the area looks fairly dry in the picture, the streambed was actually quite wet and muddy.

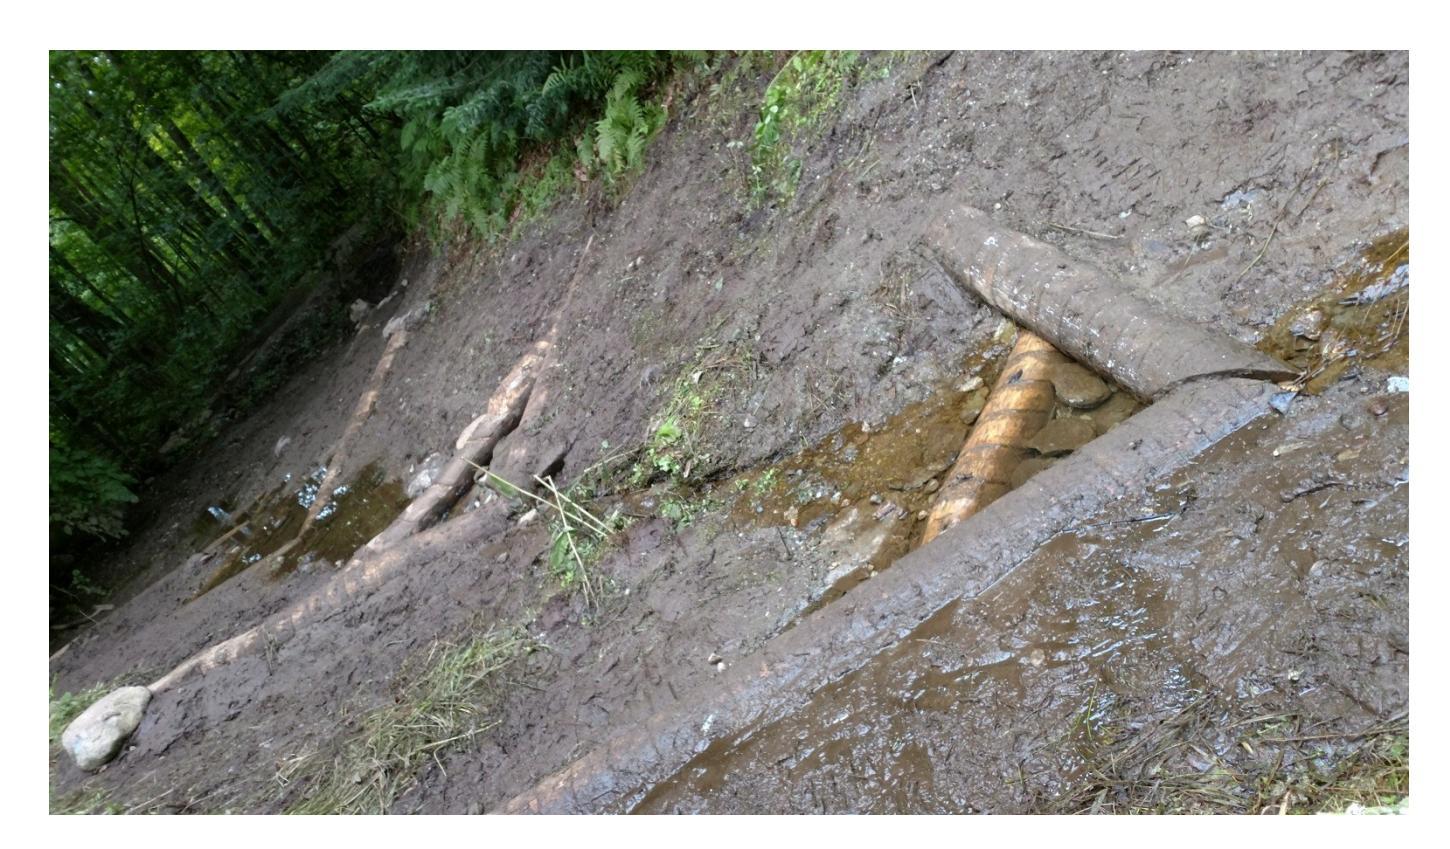
Completed check dams

View of the streambed before replanting. The timbers will not be very visible once the plants grow back in but will spread the water thereby reducing erosion and scouring, as well as trapping sediment.
